DEMONSTRATION AND VALIDATION OF THERMAL SPRAY VITRIFICATION OF LEAD-CONTAINING PAINT ON STEEL STRUCTURES

CERL TR 99/61

July 1999

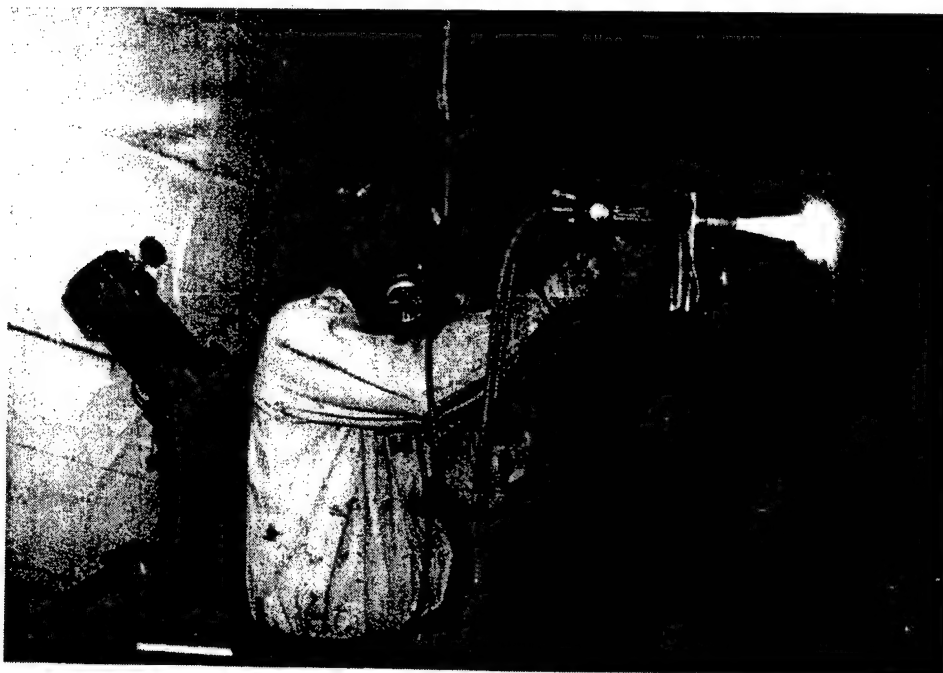
Figure B-2. Application of TSV process to Viaduct Bridge at the Rock Island Arsenal.

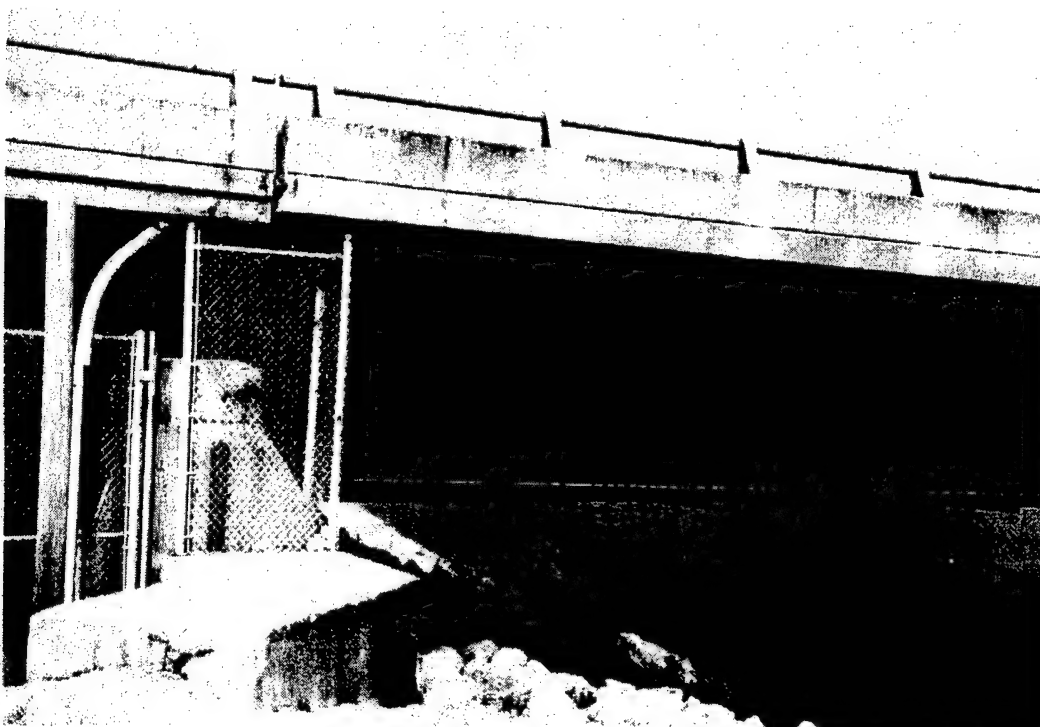
Figure B- 7. The Viaduct Bridge at the Rock Island Arsenal after the TSV demonstration.

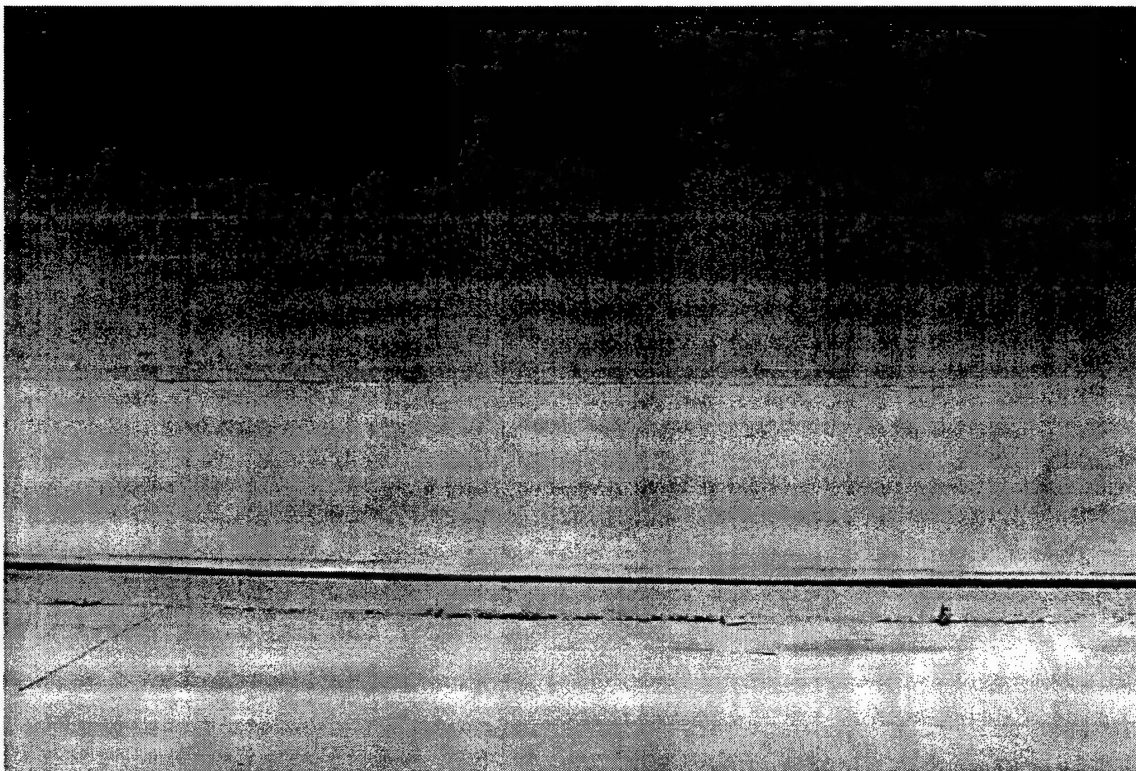
Figure B- 15. Photograph of exterior of hangar door after TSV and repainting.

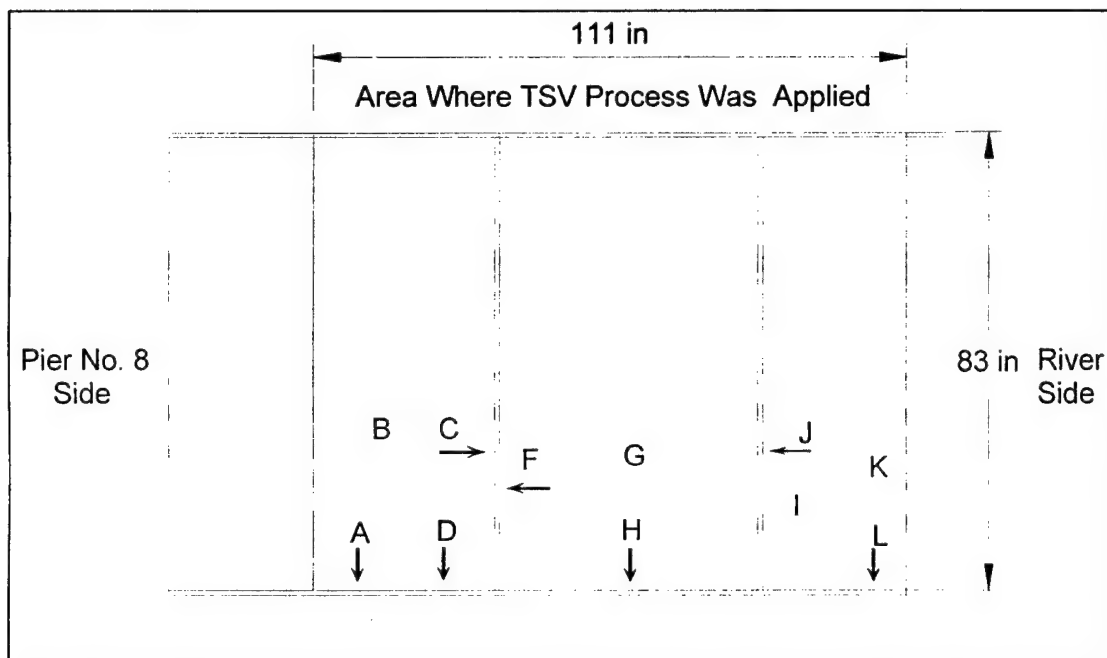
Figure C-1. Location of thickness measurements of existing paint system before application of TSV, east side.

Table C-1. Thickness of existing paint system before TSV application, east side.

Location	Measured Thickness (mils)	Measured Thickness (mils)	Measured Thickness (mils)	Average Thickness
A	11.8	10.4	9.5	10.6
B	4.7	4.3	4.4	4.5
C	6.7	7.1	7.3	7.0
D	5.0	5.5	6.3	5.6
E	3.5	3.2	3.1	3.3
F	2.3	2.2	2.6	2.4
G	5.5	6.7	5.4	5.9
H	18.1	19.6	15.7	17.8
I	7.1	6.0	6.4	6.5
j	6.3	8.3	7.6	7.4
K	9.8	9.0	7.6	8.8

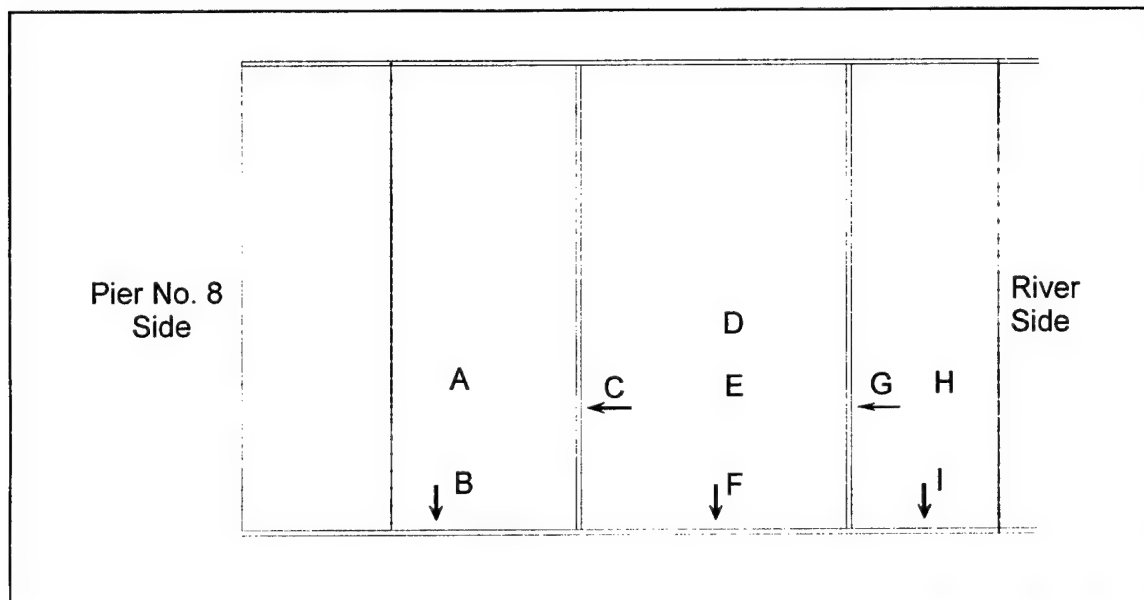
Figure C- 7. Location of primer thickness measurements after TSV application, east side.

Table C-3. Thickness of primer after application of TSV, east side.

Location	Thickness (mils)	Thickness (mil)	Thickness (mils)	Average
A	2.4	2.2	1.9	2.2
B	4.3	4.4	4.7	4.4
C	2.6	2.5	2.0	2.4
D	1.5	1.8	1.8	1.7
E	2.5	2.4	2.7	2.5
F	4.3	3.6	2.4	3.4
G	3.3	3.2	3.9	3.4
H	2.5	2.1	2.8	2.5
I	1.7	1.8	2.1	1.9

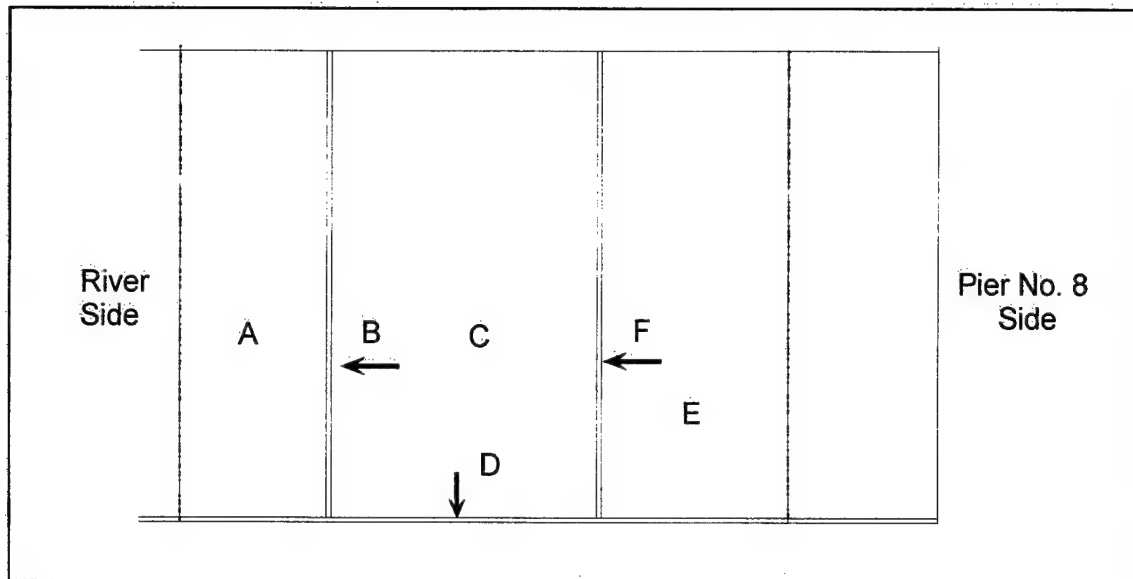
Figure C- 8. Location of primer thickness measurements after TSV, west side.

Table C-4. Thickness of the primer after TSV application, west side.

Location	Thickness (mils)	Thickness (mil)	Thickness (mils)	Average
A	2.6	2.3	2.2	2.4
B	3.0	2.7	2.2	2.6
C	2.8	2.8	3.0	2.9
D	6.0	8.8	6.6	7.1
E	1.7	2.8	2.6	2.4
F	2.3	2.5	2.0	2.3

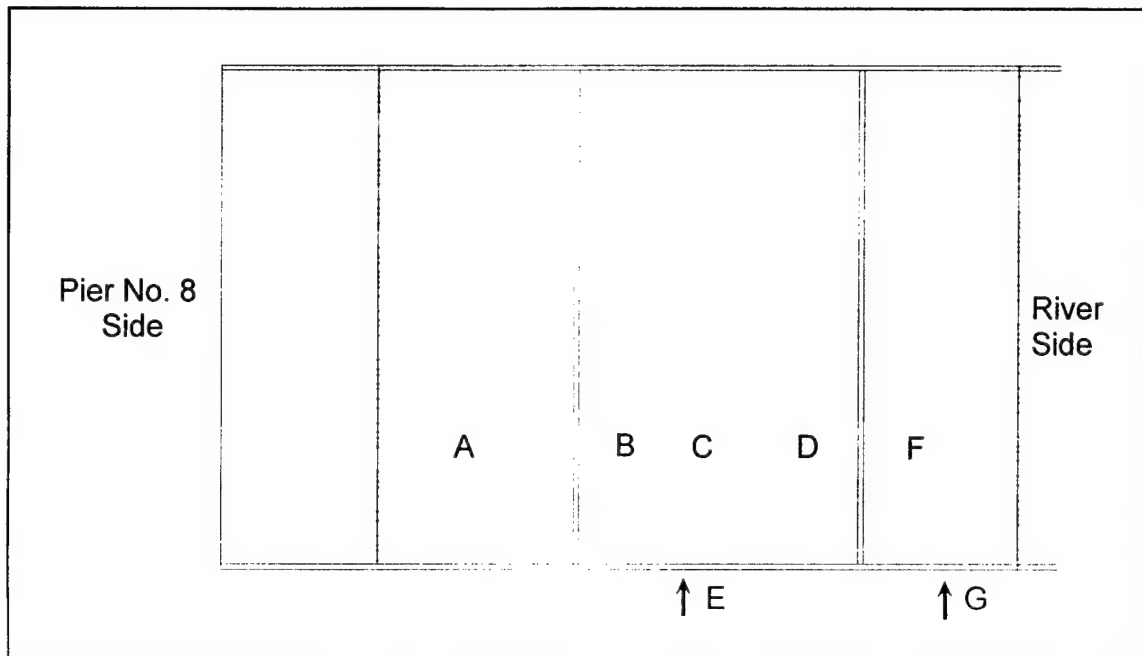
Figure C- 9. Location of thickness measurement (primer plus topcoat) after TSV application, east side.

Table C-5. Thickness of primer plus topcoats after TSV application, east side.

Location	Thickness (mils)	Thickness (mil)	Thickness (mils)	Average
A	8.2	8.4	7.4	8.0
B	6.4	6.4	6.6	6.4
C	6.6	6.4	7.7	6.9
D	7.1	8.3	7.4	7.6
E	6.6	7.6	6.2	6.8
F	6.3	6.1	6.0	6.1
G	8.3	8.4	8.5	8.4

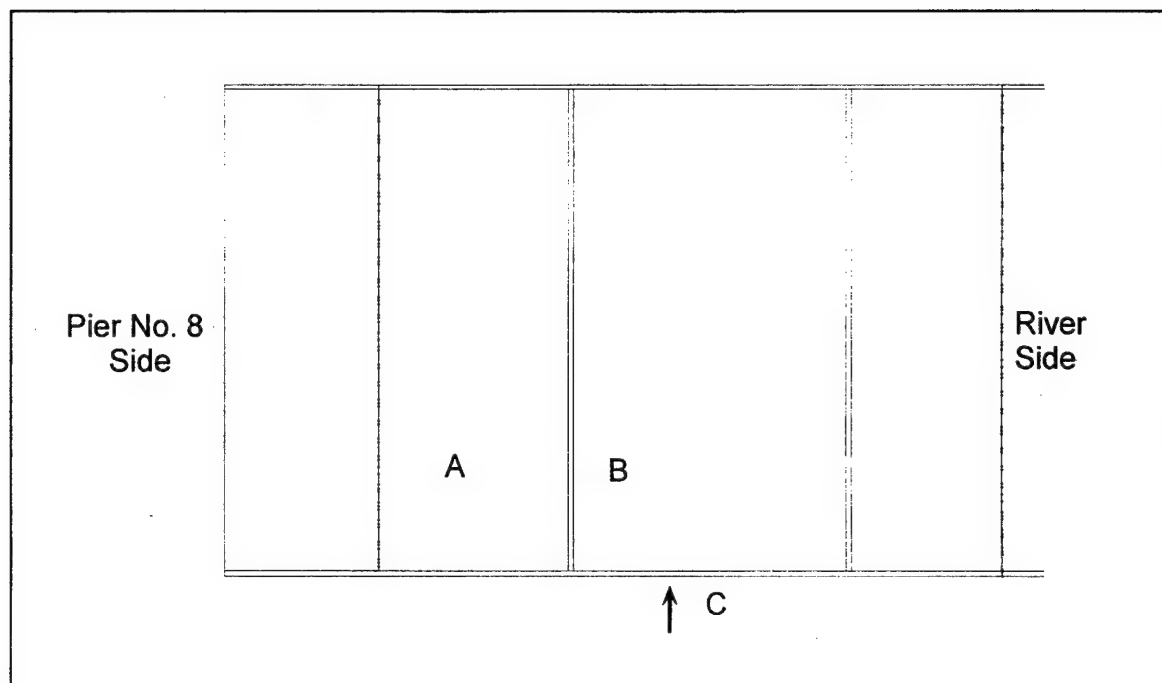
Figure C- 12. Location of lead-concentration measurements after TSV application.

Table C-8. Lead concentration using x-ray fluorescence spectroscopy after TSV application, east side.

Location	Instrument Sample No.	Lead Concentration. (mg/cm ²)
A	107.2	1.03
B	107.3	2.32
C	107.5	1.46

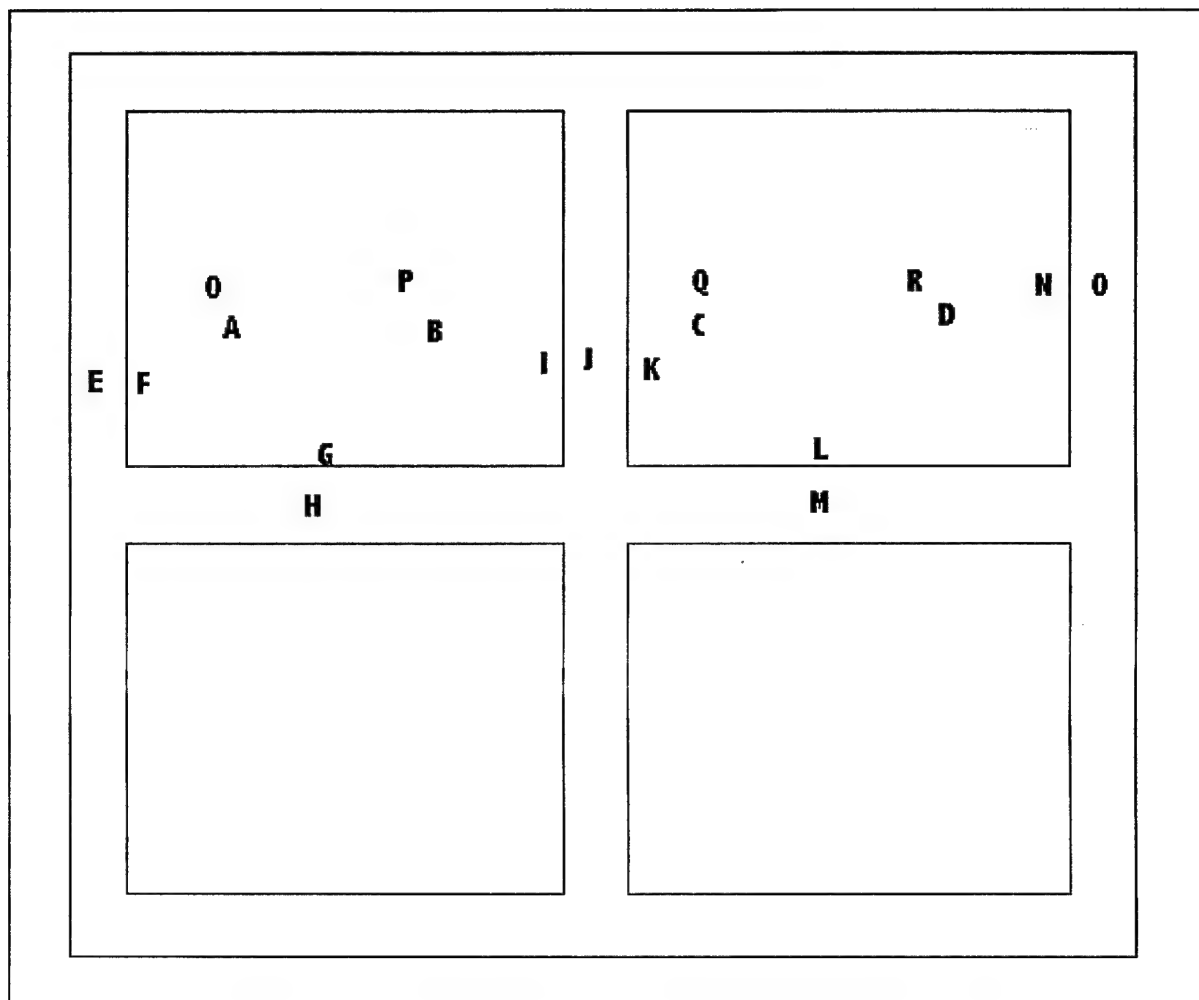
Figure D- 3. Locations of XRF measurements before TSV.

Table D-4. Lead concentration measurements before TSV.

Outside Skin	Lead, mg/cm ²	Inside Skin	Lead, mg/cm ²	Framing	Lead, mg/cm ²
A	1.72	O	4.27	E	19.95
B	2.77	P	9.07	F	12.29
C	1.43	Q	5.37	G	14.42
D	4.39	R	3.06	H	2.79
				I	16.57
				J	13.31
				K	13.76
				L	12.5
				M	9.44
				N	13.25
				O	11.5

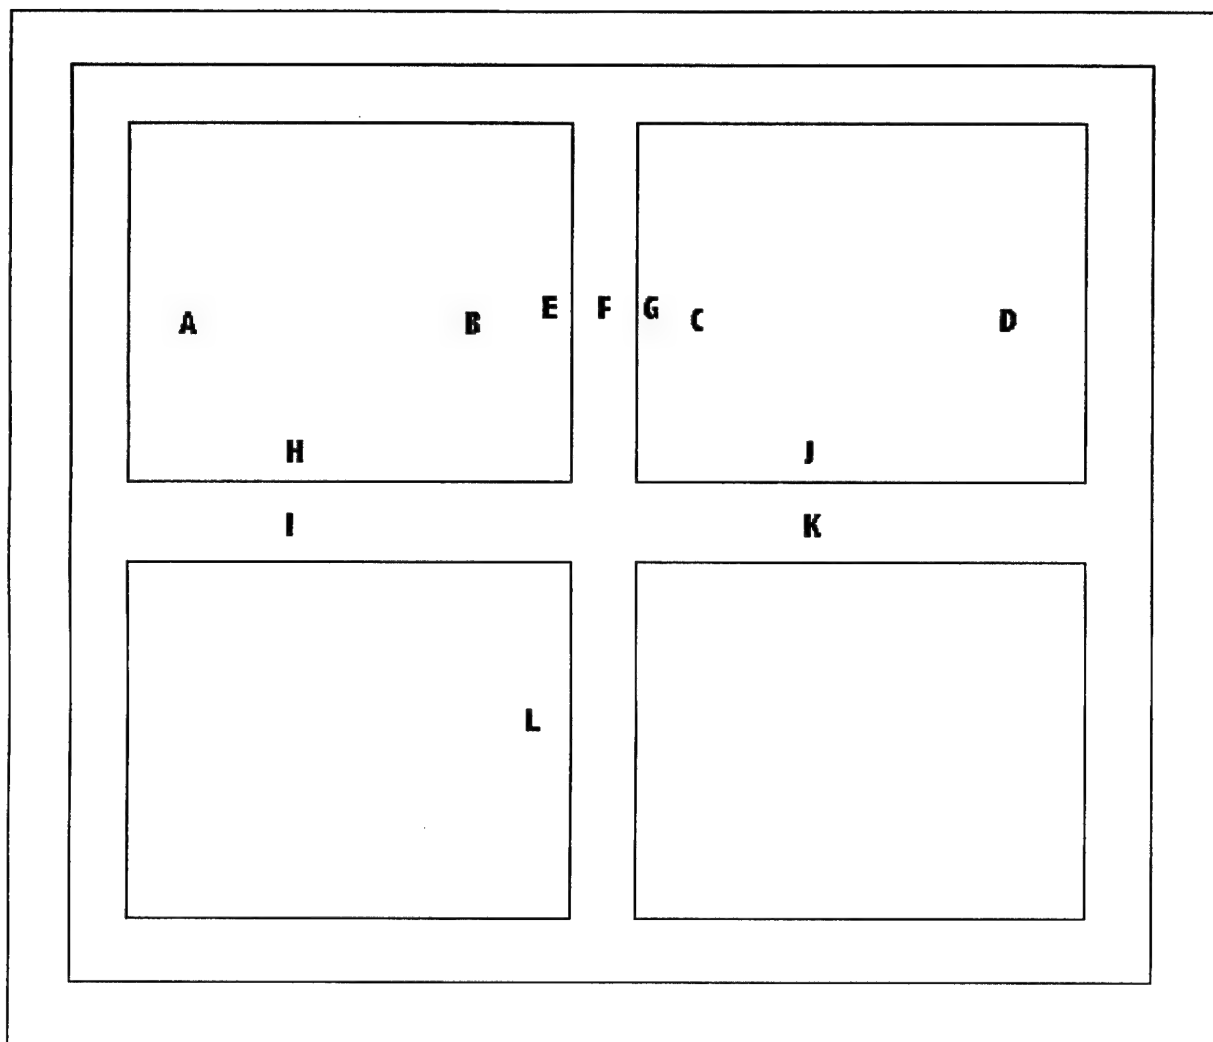
Figure D- 4. Location of XRF measurements after TSV and before needle gun cleanup.

Table D-5. Lead concentration after TSV and before needle gun cleanup.

Inside Skin	Lead, mg/cm ²	Framing	Lead, mg/cm ²
A	0.14	E	1.82
B	2.88	F	1.10
C	1.9	G	5.63
D	0.94	H	1.59
		I	2.95
		J	3.33
		K	1.29
		L	3.51

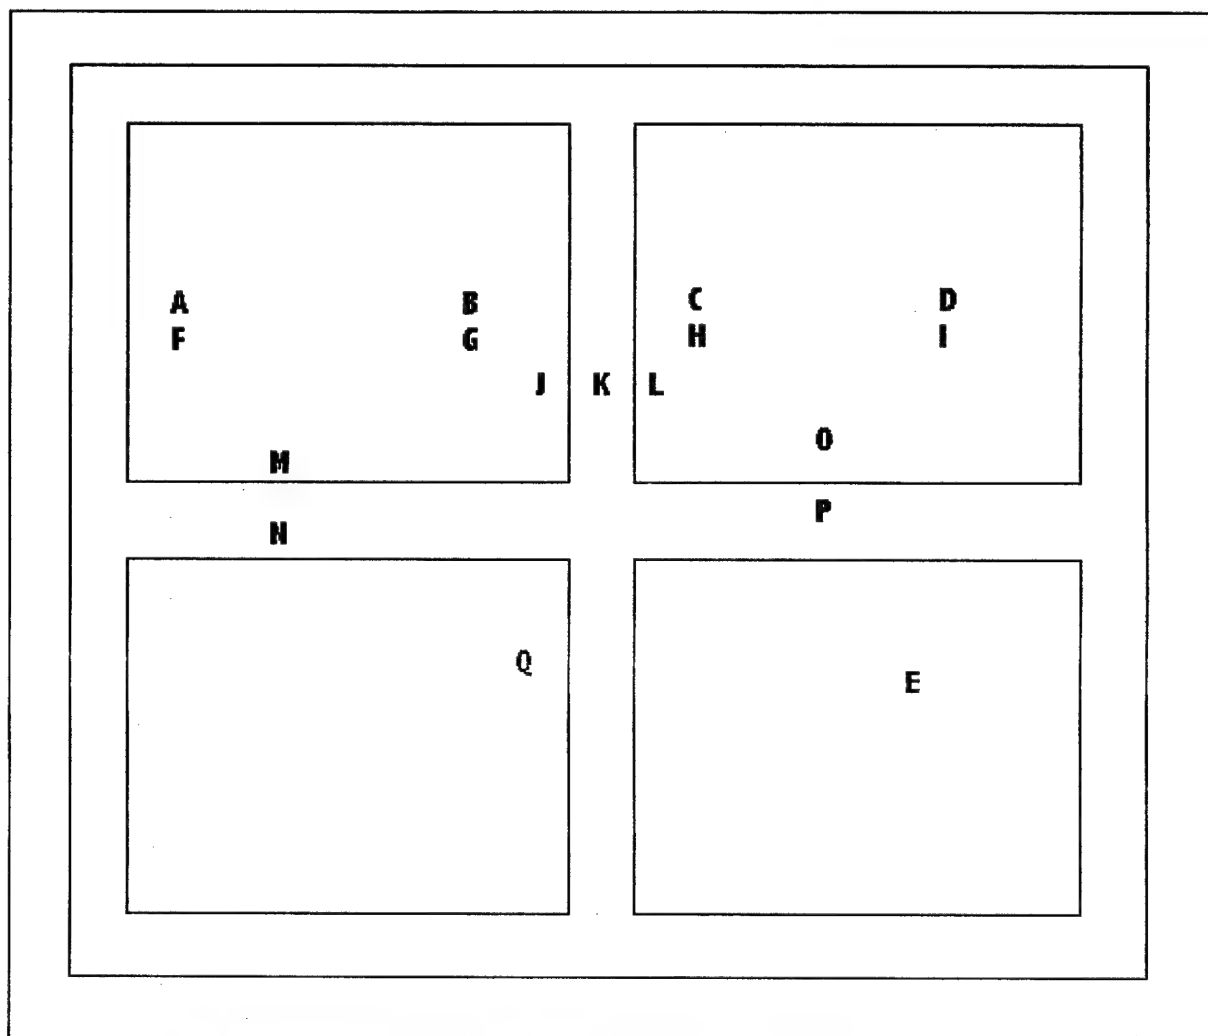
Figure D- 5. Locations of XRF readings after needle gun cleanup.

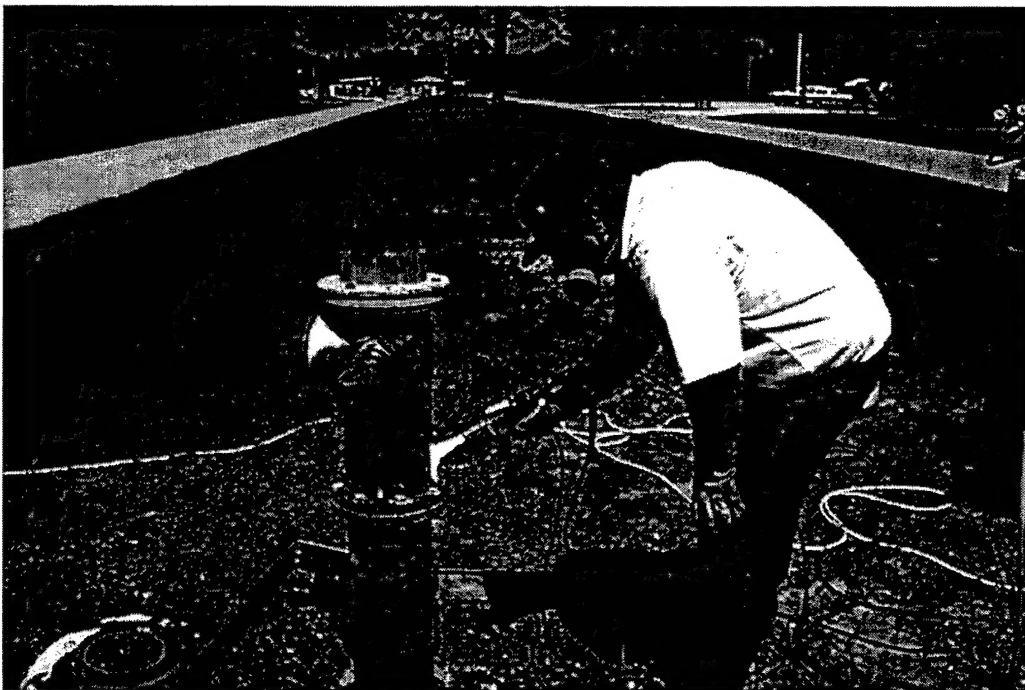
Testing of the hydrants after cooling by opening the valve and filling the body with water under pressure showed that the seals and gaskets on the first hydrant were adversely affected by the heat of vitrification. Repair of the hydrant will require about \$60 worth of gaskets and seals and about 2 man-hours of labor. The second hydrant was tested and no damage to the gaskets or seals was found. An analysis of the procedures used on each hydrant showed that the first hydrant was overheated because of improper gas pressure for the glass feed system. As a result, heating was not uniform throughout the hydrant. The feed gas pressure was properly set for the second hydrant from the beginning.

Figure F- 6. TSV application on hydrant near Building 6029.
